Ladybarn, Manchester

Project description	Whole house retrofit of mid-terrace house, built c.1888.			
Treated Floor Area	60.5 m ²			
Dates of work	2013			
Project team	Myself (PHPP analyst, project coordinator & builder labour), a local contractor team (Expert Home Extensions), plus additional contractors for plumbing, electrics and plastering.			
Introduction	The house was cold and draughty, with several air bricks at various points in the walls. The bathroom in particular was always cold. The client borrowed some temperature sensors, and we estimated an average temperature in the house of around 15°C, since the client heated only some rooms and not others. The renovation was done as a full-blown learning exercise, where the client agreed to take the risk with us regarding the measures being suggested and projected costs (which ended up being double what I originally estimated). However, accurate timesheets with allocated hours per job has allowed me to have a much better estimate of what various improvements cost (e.g. cost of internal wall insulation per m ²).

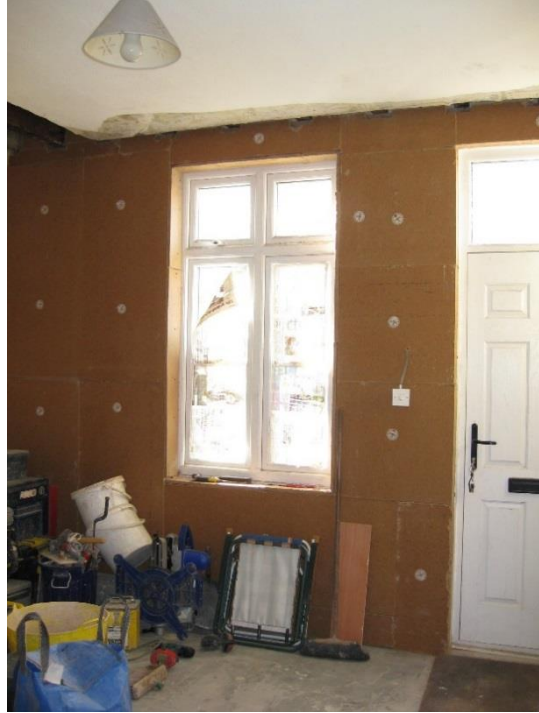
- Wood fibre boards 80mm thick fixed direct to wall with concrete screws and plastic washers, u-value 0.36 W/m²K
- Keim Lotexan mineral paint applied on external wall face (2 coats) to reduce rain-driven moisture into brickwork

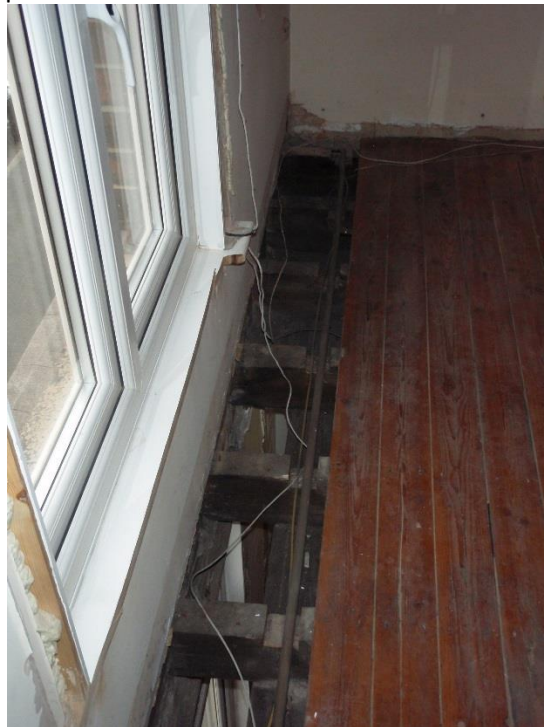
- Insulation was continuous through floor void, which entailed cutting out floorboards and ceiling plasterboard to accommodate it.

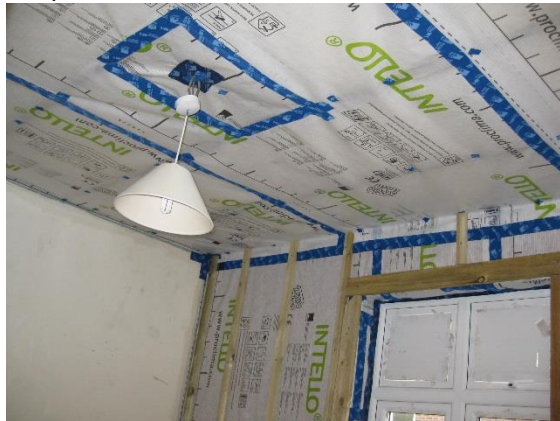
- Vapour-permeable Intello membrane was used on insulated internal walls, and bathroom & bedroom ceilings. Tescon 1 tape was used to join sheets, and Orcon F was used to fix membranes to ground floor and party walls. Tescon Primer RP was used to prime solid surfaces prior to tapes or Orcon F being used.
- All service penetrations (e.g. wires, ducts, boiler flue, etc) had to be dealt with using grommets or tapes.
- A 25mm service zone was added in front of membrane on walls for pipes and wires.
- The same type of baton was used for one of the bedroom ceilings in order to aid plasterboard fixing. For the other bedroom ceiling, the membrane was fixed to a more substantial wood frame which was installed to remedy an old sagging ceiling (along with purlin supports in the loft).

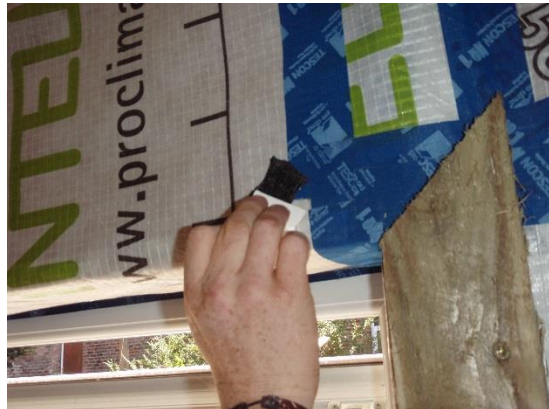
- Naidec (black double-sided sticky tape) was used prior to service zone batons being fixed, in order to maintain airtightness after the drill had created a hole for the concrete screw.

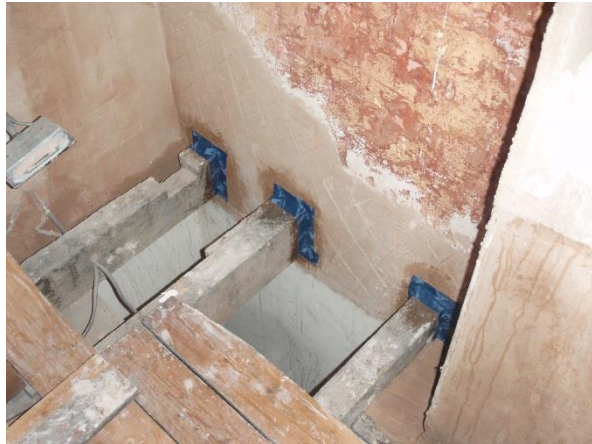
- No membrane was used on the ground floor or party walls – here we relied on the existing surfaces, but for the party wall, this had to be re-plastered in places, and previously unplastered areas (e.g. between floor voids) also had to be plastered.
- After plastering, joist ends were taped to plaster, with a second skim coat over the tapes (we had joist ends going into both party wall and external wall in this house).

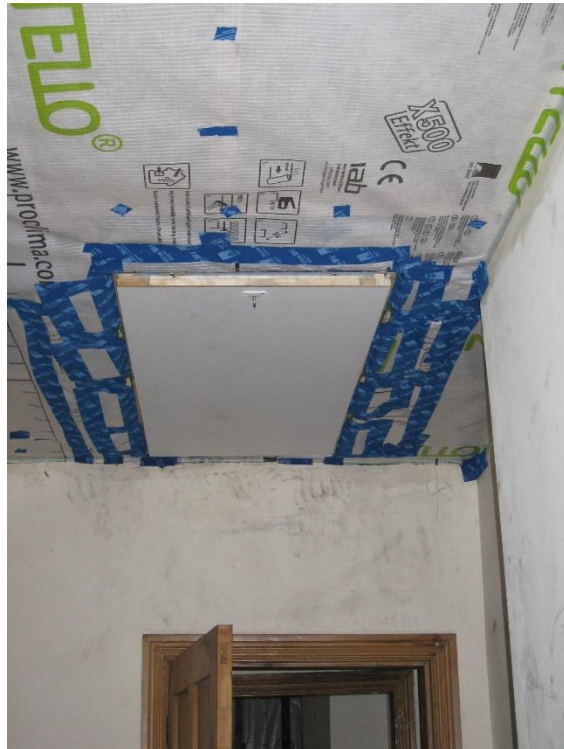
- Airtight loft hatches were installed to access bathroom and bedroom lofts.

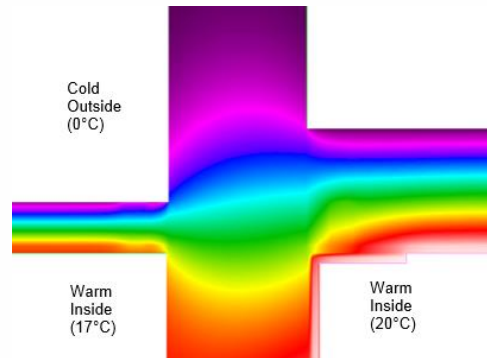
- All junctions were modelled using THERM. Where the junction was losing heat, a solution was modelled in order to reduce the heat loss so that it was close to zero.

- Problem junctions that needed a specific solution included:
 - o Party wall to loft (= model above)
 - o Party wall to ground floor
 - o Party wall to external-facing wall (in vertical profile)
- Modelling showed that using Spacetherm-P (plasterboard bonded to aerogel, a high-grade insulation material) solved the problem while also allowing the thermal bridge solution to blend in and not be too bulky. In most cases, a 20cm strip of Spacetherm-P was required.

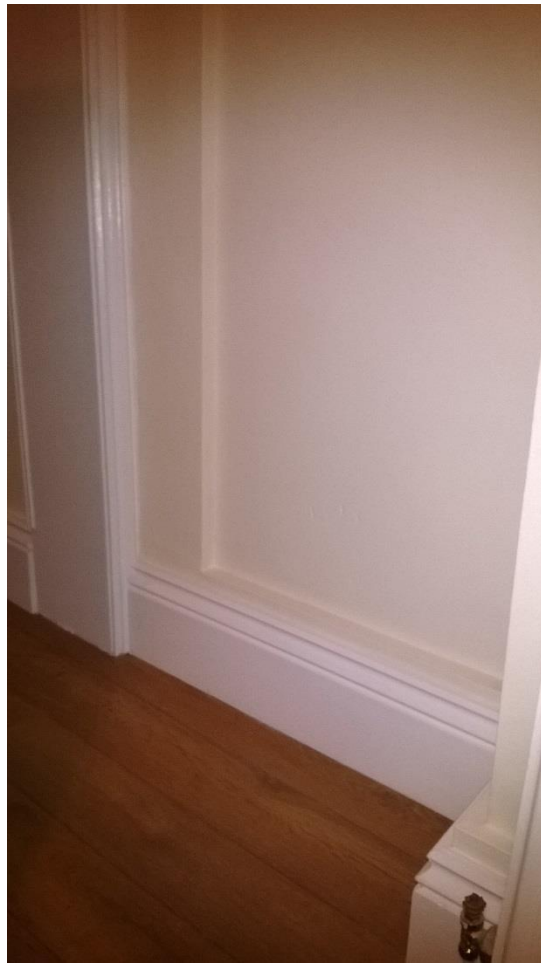
- The end result with plastering (and skirting in front) produced a surprisingly pleasing visual result that blended in well.

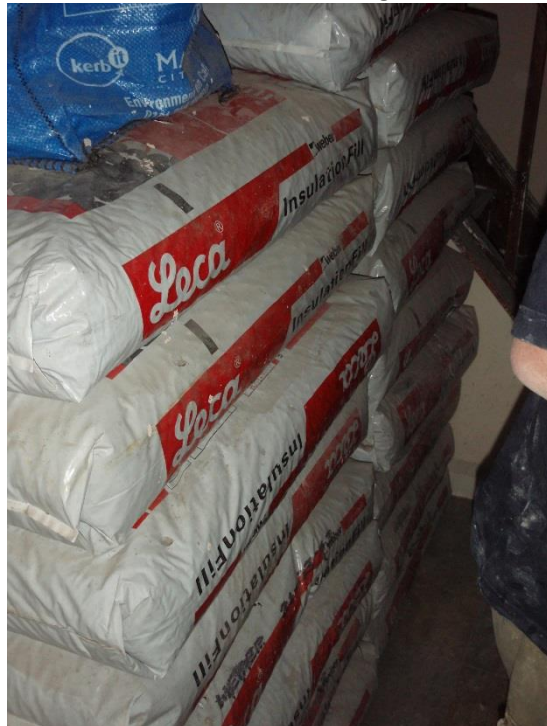
- As part of the airtightness strategy all chimney breasts had to be checked to make them airtight. Often this meant opening them up in order to brick them up properly.
- In order to address any longer-term issues of moisture tracking down the chimney breasts and accumulating (a possible risk when vents are blocked up), we had the following strategy:
 - o Chimney flues were cleaned by a chimney sweep
 - o Chimney breasts were bricked up while leaving a small inspection hole in each one to check the Leca beads
 - o Leca (fired clay balls) was then added into each flue up to the level of the loft floor – we used the inspection holes to ensure that it had reached all parts of the flue.

Leca has some insulating properties, but also allows moisture regulation.

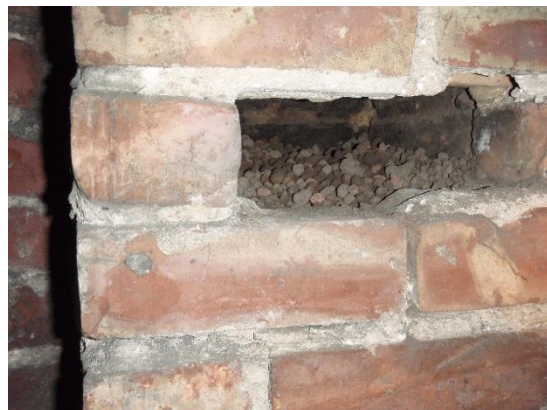
- The part of the chimney flue in the loft space up to the stack was kept empty, and air was allowed to circulate in this void by taking a brick out of each flue in the loft space. This is the part of the flue with most damp potential, so this part was where we ventilated.
